# SEAWALL HABITAT ENHANCEMENT PROJECT

## MONITORING REPORT

### YEAR 1

**DATE:** THURSDAY, 18 JANUARY 2024  
**PERMIT:** DA2022/05/01  
**REFERENCE** 2204-28537 SRA

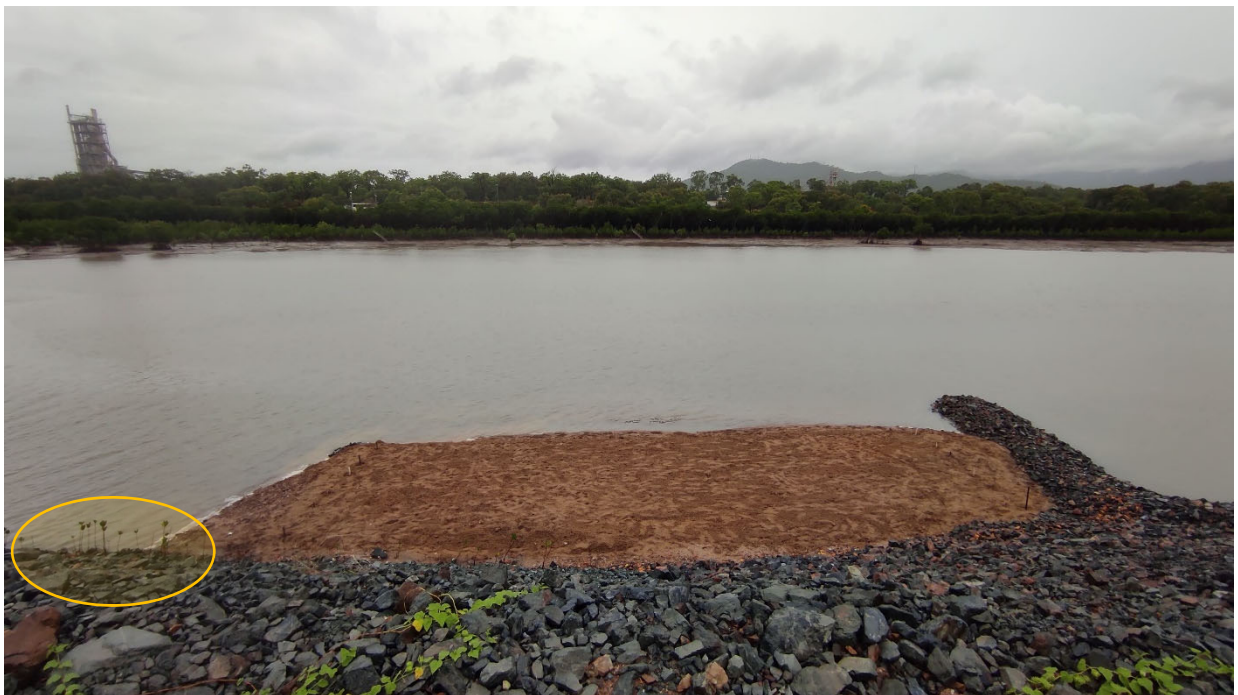
**Figure 2:** Photo of one of the completed sites, taken in January 2023. In the lower left of the image, along the base of the rock wall, there are some mangrove saplings visible – these and others similar were included in the disturbance estimate submitted as part of the original development application, but were left undisturbed during the construction process.

The eventual disturbance to marine plants as a direct result of construction activities was less than initially estimated, as construction was able to occur in a way that minimised impact and was over a lesser total footprint. Based on the 'For construction' and 'As constructed' drawings the total footprint approved was approximately 1290 m<sup>2</sup> and the total footprint disturbed was approximately 660 m<sup>2</sup>, which is just over 50%.

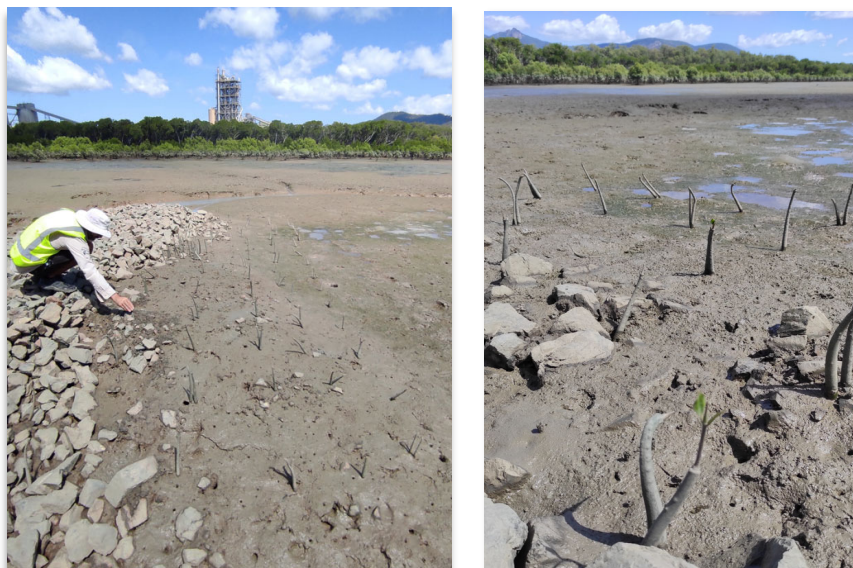
Figure 4: Mangrove propagules planted adjacent to the two (2) sites without sediment banks. Planted within similar 1m<sup>2</sup> plots as above grouped as either single propagules, pairs or in high density

In March 2023, mangrove propagules, collected locally, were planted adjacent to the two (2) rock groynes without sediment banks. On the downstream side of Site 2, 100 propagules were planted and another 100 on the upstream side of Site 3.

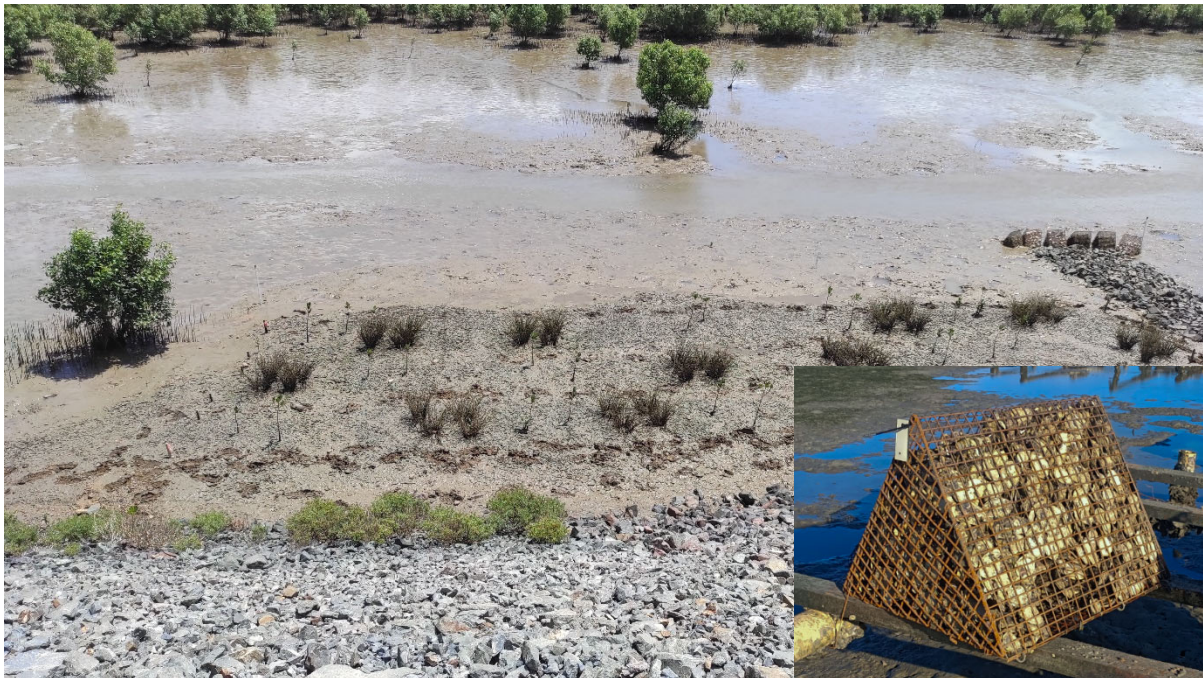
**Figure 5:** Site 1 showing ROBAs deployed

The method chosen for the recruitment of oysters was using a 400 mm tall triangular Robust Oyster Basket (ROB 400). Due to the timing of the groyne construction, oyster specialists (OzFish) and scientists at CMERC advised that the deployment of ROBAs should match the spawning season of oysters, which was thought to be sometime in the summer months. There is limited reference material regarding the spawning season of sub-tropical oysters, compared to the more temperate locations. To be able to monitor a full spawning season, the deployment of ROBAs was accordingly delayed. The first deployment of 15 ROBAs occurred in October 2023 (spring) and the second deployment of 15 ROBAs took place in January 2024 (summer) (Figure 5).

The ROBAs were placed at the leading edge of each groyne and their deployment marked the completion of project installation.

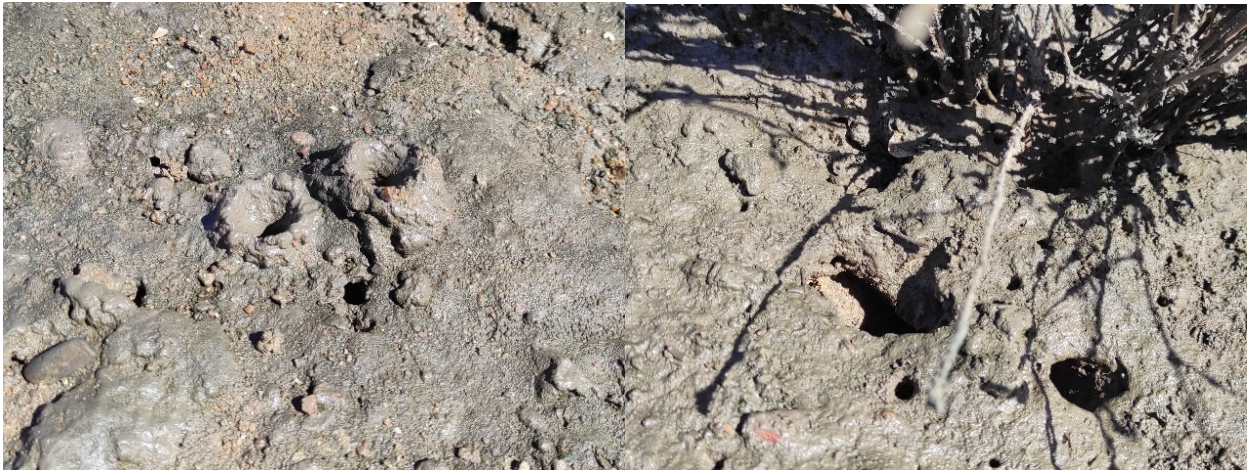
**Figure 6:** Crab holes observed at the created 'beach' sites in April 2023

After construction of the sediment banks, no invertebrates were recorded at the three (3) sites (Sites 1, 4, and 5) until June 2023. However, crabs and crab holes were observed prior to this (in April 2023)(Figure 6). By October 2023, infaunal invertebrates have started to return including soft bodies polychaete worms (Figure 7). Samples are being identified and counted and will be reported in subsequent reports.
